## Westinghouse Bus Duct Project Overview

| <b>Project Type:</b> | Westinghouse Bus Duct (480V, 1600A) Repair |

## Emergency Repair Project Overview

| <b>Project Type:</b> | Bushing Box (15kV, 1200A) Rebuild |

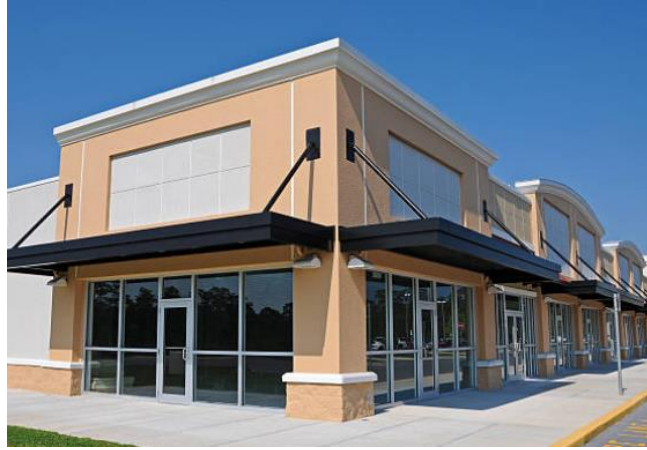
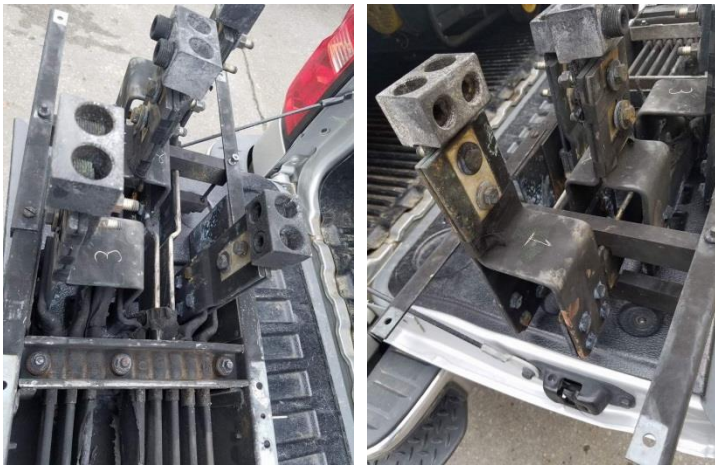
The existing bus had a failure when a shorted the bus phase-to-Phase. This customer needed the bus duct rebuilt to match the existing obsolete bus duct. It was the final length of bus duct that connected to the distribution switchgear, there was no time manufacture a complete run of bus duct.

We reverse engineered the obsolete Westinghouse bus duct and returned it to like new condition. Working around the clock we were able to complete the work in less than 24 hours.

- All new copper bus with fluidized bed epoxy insulation
- New glass polyester bus supports
- New sheet metal covers
- The frame was sand blasted and repainted
- All new hardware and cable lugs

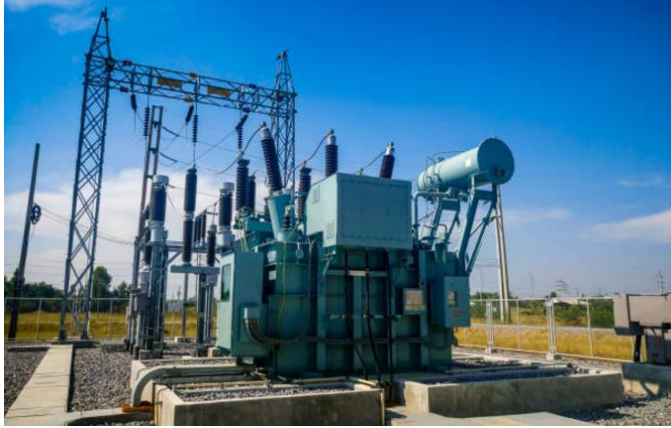
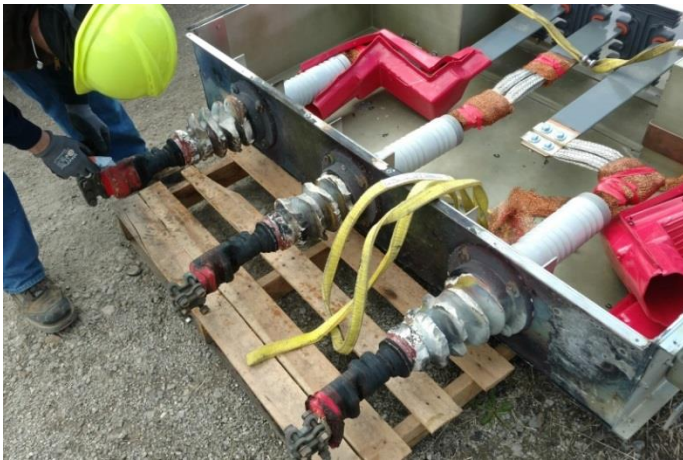
This was an emergency project for an manufacturing facility that could not afford much down time. A squirrel shorted out the bushings and it needed repaired within 24 hours.

With little time on our hands, we worked around the clock to get this job done properly and on time. We rebuilt the bushing box including the following components:

- New porcelain bushings
- New copper bus adapters
- Re-plated and insulated the existing copper bus
- Supplied and installed new bus boots
- Re-painted the entire enclosure
