## Westinghouse Bus Duct Project Overview

**Project Location:** Charleston, WV  
**Market Segment:** Large Retail Provider  
**Project Type:** Westinghouse Bus Duct (480V, 1600A) Repair

## Emergency Repair Project Overview

<b>Project Location:</b>	Sandusky, OH
<b>Market Segment:</b>	Industrial Manufacturer
<b>Project Type:</b>	Bushing Box (15kV, 1200A) Rebuild

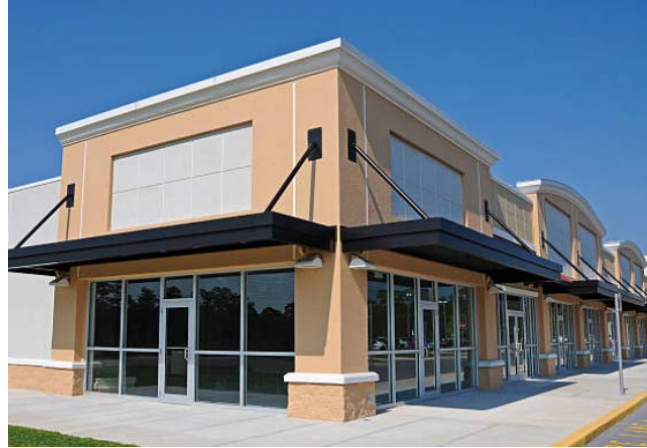
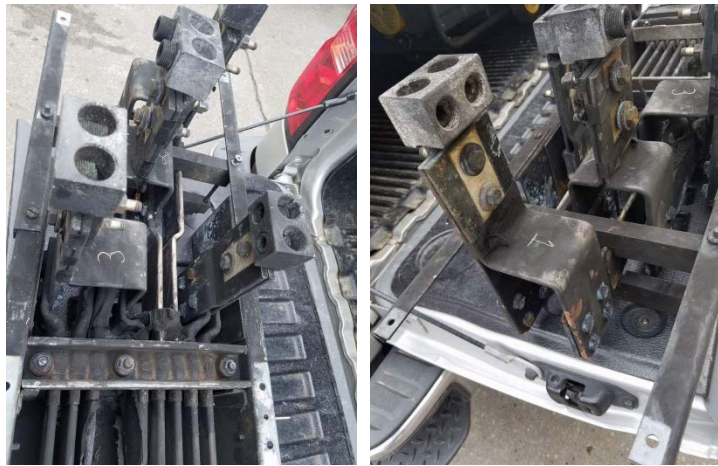
The existing bus had a failure when it shorted the bus phase-to-phase. This customer needed the bus duct rebuilt to match the existing, obsolete bus duct. It was the final length of bus duct that connected to the distribution switchgear, and there was no time to manufacture a complete run of bus duct.

We reverse engineered the obsolete Westinghouse bus duct and returned it to like new condition. Working around the clock, we were able to complete the work in less than 24 hours.

- All new copper bus with fluidized bed epoxy insulation
- New glass polyester bus supports
- New sheet metal covers
- Sand blasting and repainting the frame
- All new hardware and cable lugs

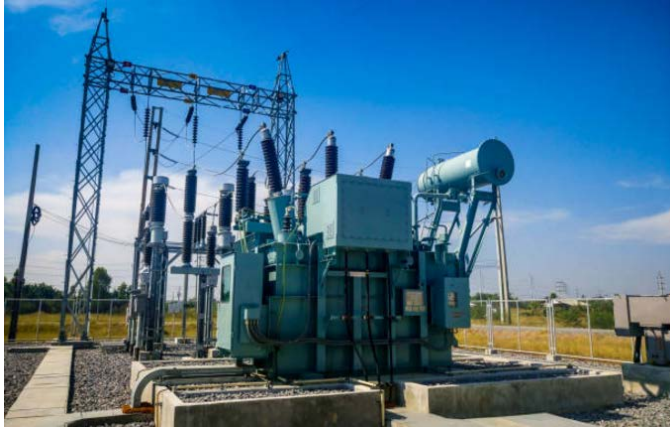
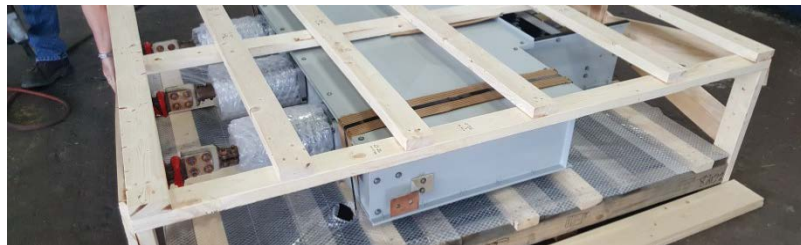
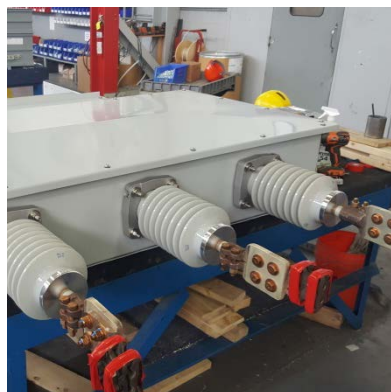
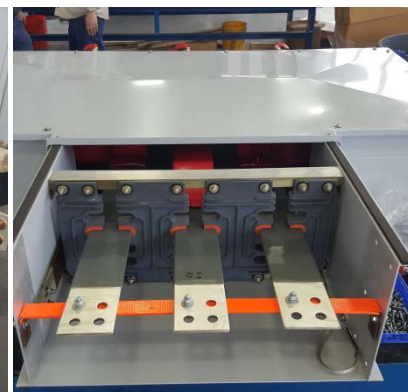
This was an emergency project for a manufacturing facility that could not afford much down time. A squirrel shorted out the bushings, and it needed to be repaired within 24 hours.

With little time on our hands, we worked around the clock to get this job done properly and on time. We rebuilt the bushing box, including the following components:

- New porcelain bushings
- New copper bus adapters
- Re-plating and insulating for the existing copper bus
- New bus boots - supplied and installed
- Re-painting for the entire enclosure
