Westinghouse Bus Duct Project Overview

Project Location: Charleston, WV
Market Segment: Large Retail Provider
Project Type: Westinghouse Bus Duct (480V, 1600A) Repair

Emergency Repair Project Overview

Project Location:	Sandusky, OH
Market Segment:	Industrial Manufacturer
Project Type:	Bushing Box (15kV, 1200A) Rebuild

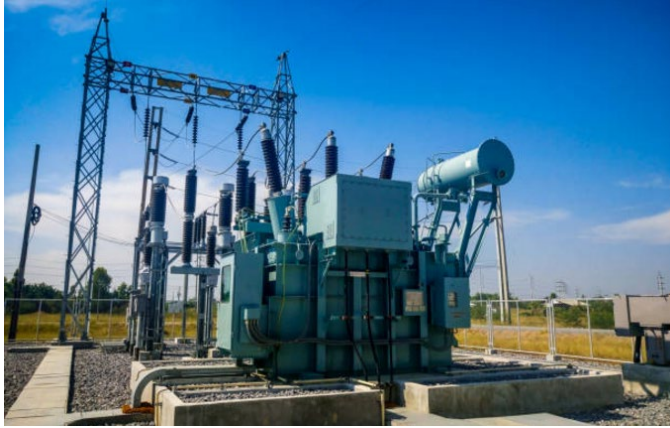
This was an emergency project for a manufacturing facility that could not afford much down time. A squirrel shorted out the bushings, and it needed to be repaired within 24 hours.

With little time on our hands, we worked around the clock to get this job done properly and on time. We rebuilt the bushing box, including the following components:

- New porcelain bushings
- New copper bus adapters
- Re-plating and insulating for the existing copper bus
- New bus boots - supplied and installed
- Re-painting for the entire enclosure
